# Peaks of Otter

## Soil & Water Conservation District

Big Otter River Watershed spans Bedford and Campbell Counties

# How is the water quality in Big Otter R. watershed?

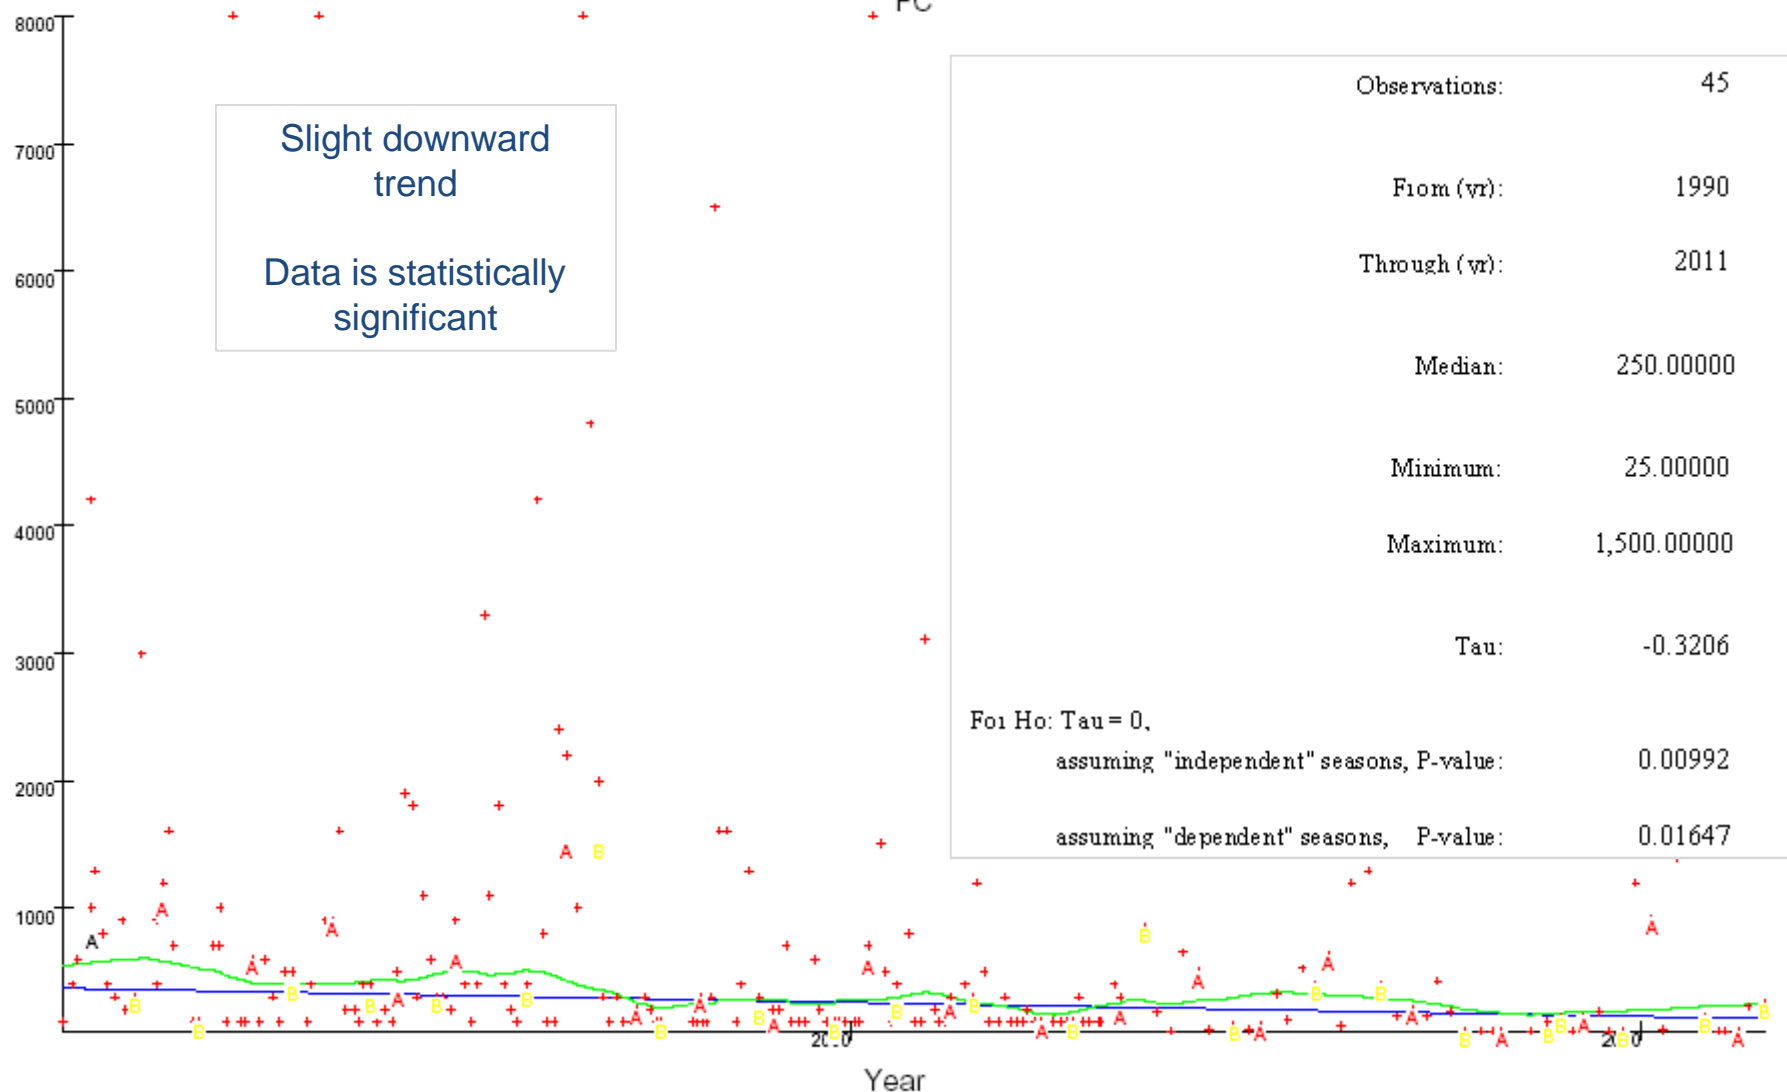
# Station 4ALOR014.75, FC

Tau = -0.320574, Ind-P = 0.009925, Dep-P = 0.016471, Slope = -11.1111 (Record LOR\_trend)

NOTE: Original Data are red. Reduced to medians data are colored symbols.

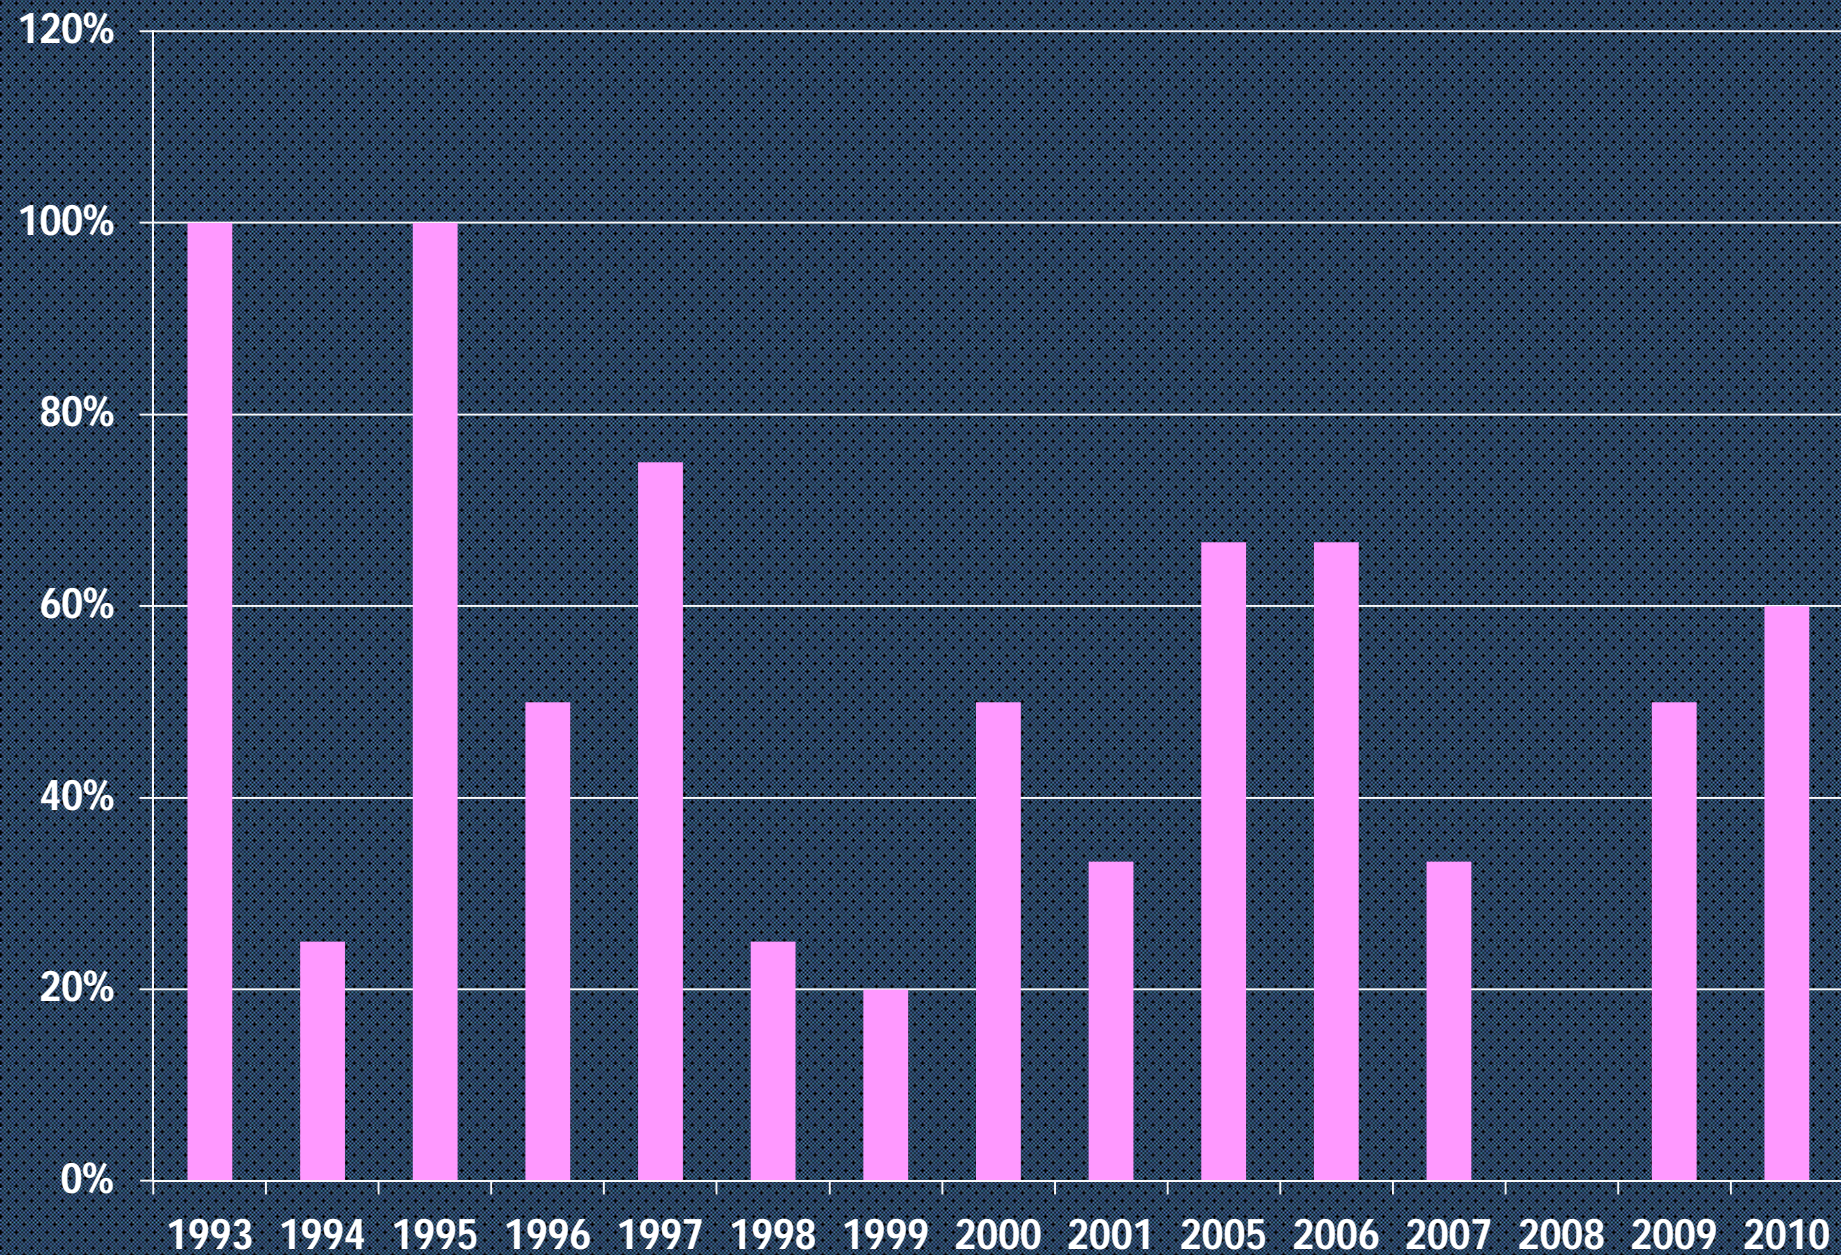
# Fecal Coliform Interim Standard (400 cfu/100mL) Violation Rate at Elk Creek Station 4AECR003.02 (1990 – 2011)

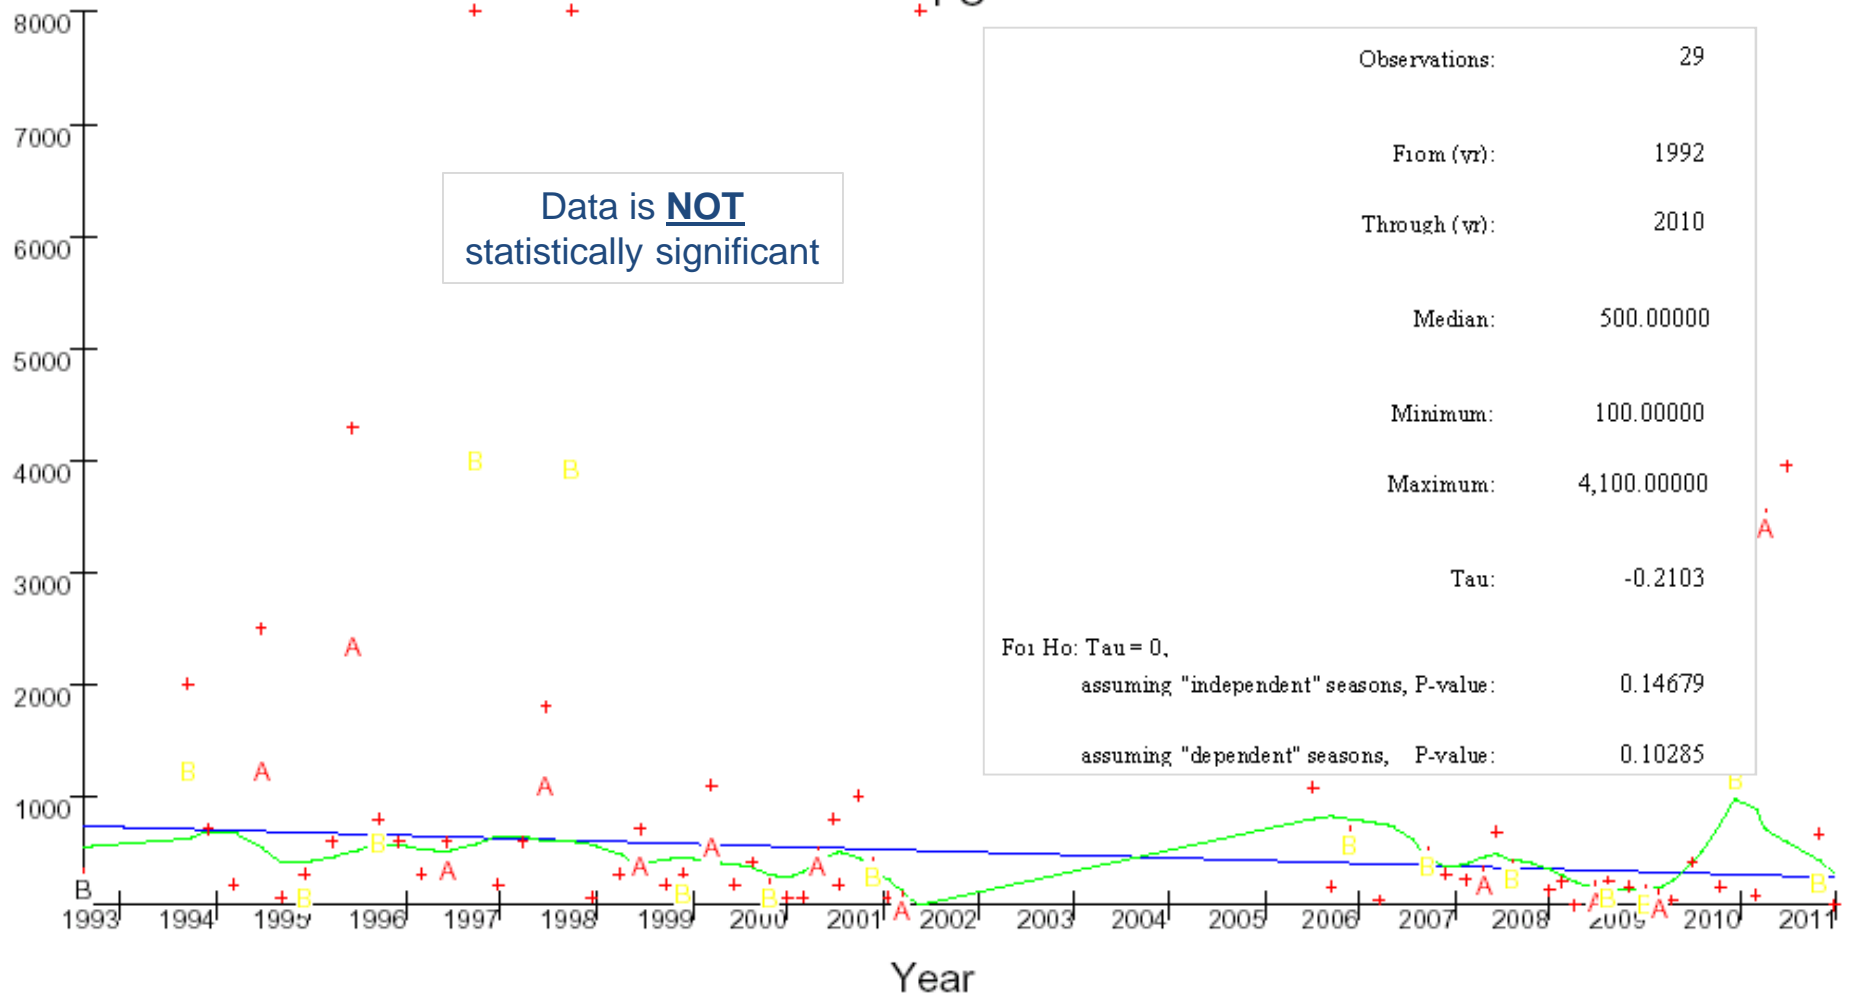
# Station 4AECR003.02, FC

Tau = -0.210256, Ind-P = 0.146793, Dep-P = 0.102852, Slope = -24.8034 (Record Elk)

NOTE: Original Data are red. Reduced to medians data are colored symbols.
